melett

LACK OF LUBRICATION /OIL STARVATION

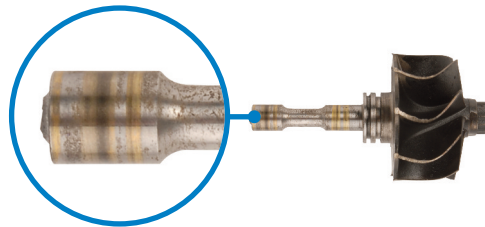
Material transfer from journal bearing

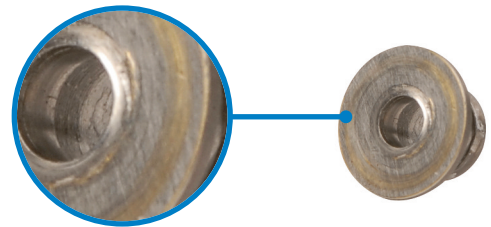
Material transfer from thrust bearing

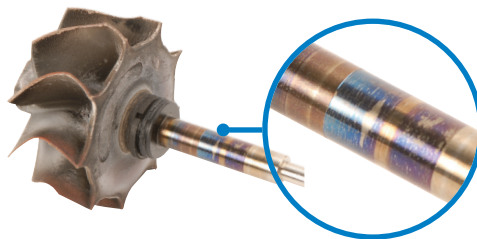
Discolouration to diameter of shaft & wheel

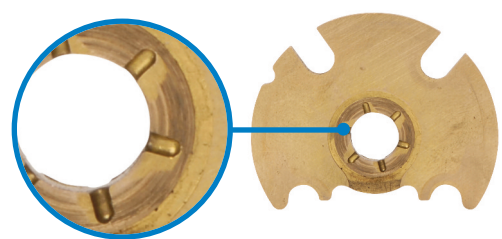
Excessive wear to thrust bearing

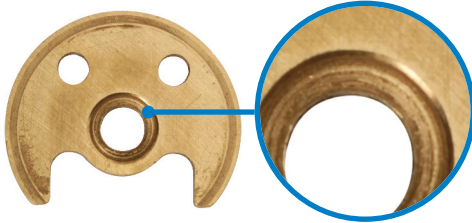
Excessive wear to thrust bearing

- Oil supply is critical to the turbo, please ensure the oil flow is correct
- Always remember to prime the replacement turbocharger with oil before fitting
- Do not use silicone on oil gaskets as it can easily become detached and block oil passages
- Clean or replace oil inlet pipes to remove carbon deposits or sludge that could restrict oil flow to the bearing systems
- Use fresh oil and new oil filters (which have been recommended by the engine manufacturer) when fitting a replacement turbocharger
- Allow time for the engine to warm up at the start of each journey and cool down at the end

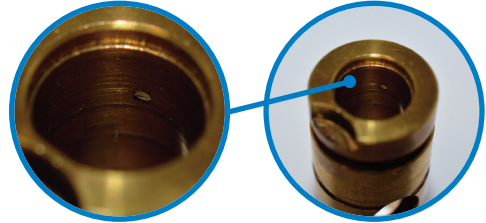
Excessive wear to journal bearing
