melett

PRECISION ENGINEERED
TURBOCHARGERS & PARTS

REA/SREA/UTA SMART/UTA
SIMPLE FAILURE MODES

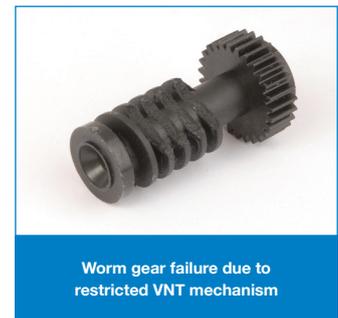
- **Gearbox Failure** - *REA/SREA/UTA Smart/UTA Simple*'s will fail if the nozzle ring assembly has any form of restriction, this could be due to sludging or carbon build-up. When the nozzle ring assembly is restricted, it pulls a higher current through the motor than it is designed to take, this therefore causes the motor to burn out or the plastic worm gears to fail. This restriction can reduce boost pressure and can result in the vehicle being put into 'limp home mode'. In most failures, the black cap and electronics are unaffected by the gearbox failure and can be reused

Worm gear failure due to restricted VNT mechanism

- When repairing electronic actuators, you need to change all the damaged/effected components
- Check all connecting wires
- Ensure bolts are tightened to the correct torque setting
- Check VNT mechanism for restrictions
- Check the wiring harness condition
- Check black cap is free from damage

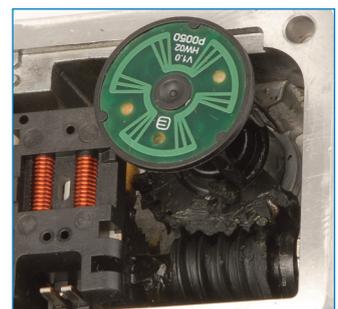
CIPOS gear, worm gear and motor failure. A complete gearbox is required with failures of this nature.

If you are going to carry out a repair on an electronic actuator, you must replace the motor and gearbox together for the correct gear ratio.
