melett

OVERHEATING

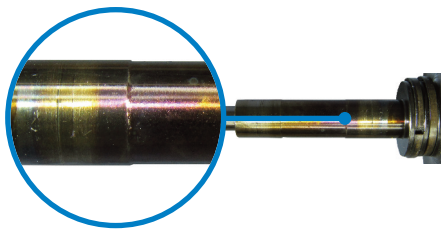
Discolouration of shaft

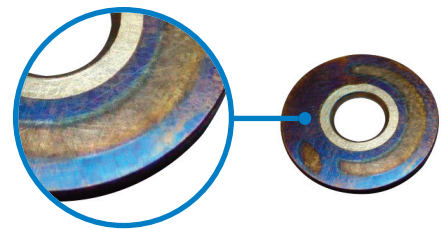
Discolouration of internal parts

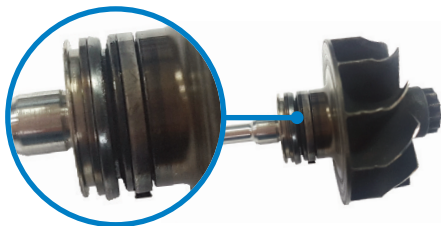
Excess wear to turbine end piston ring and groove

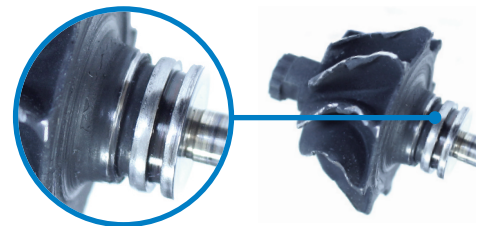
Excess wear to turbine end piston ring and groove
