PRECISION ENGINEERED  
TURBOCHARGERS & PARTS

## INSUFFICIENT LUBRICATION

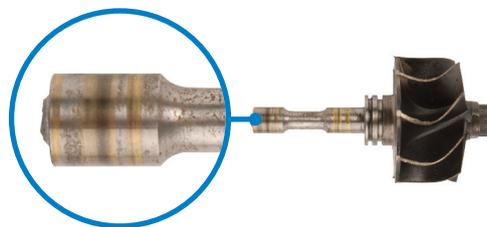
Material transfer from journal bearing

- Oil supply is critical to the turbo, please ensure the oil flow is correct
- Always remember to prime the replacement turbocharger with oil before fitting
- Do not use silicone on oil gaskets as it can easily become detached and block oil passages
- Clean or replace oil inlet pipes to remove carbon deposits or sludge that could restrict oil flow to the bearing systems
- Use fresh oil and new oil filters (which have been recommended by the engine manufacturer) when fitting a replacement turbocharger
- Allow time for the engine to warm up at the start of each journey and cool down at the end

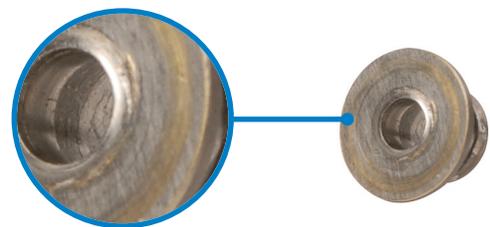
Material transfer from thrust bearing

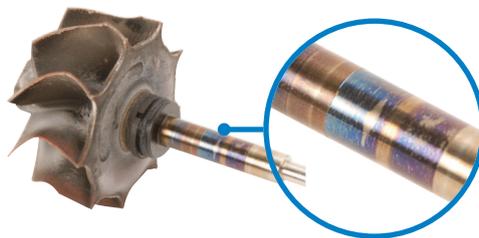
Discolouration to diameter of shaft & wheel

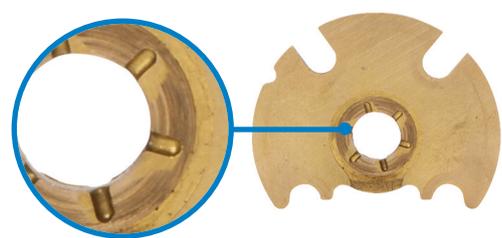
Excessive wear to thrust bearing

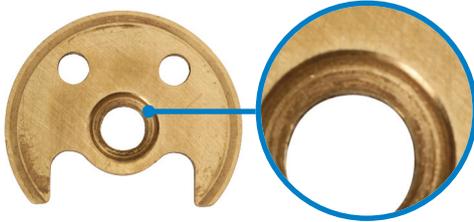
Excessive wear to thrust bearing

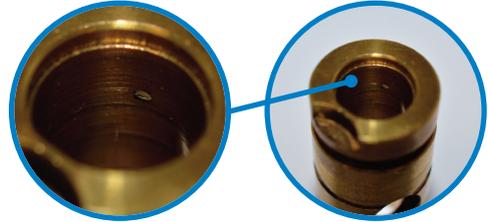
Excessive wear to journal bearing
