melett

OVERHEATING

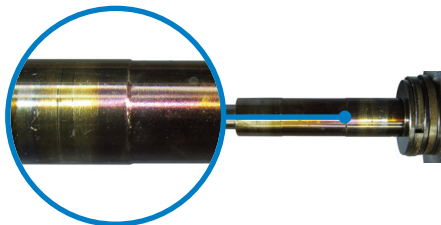
- Discoloration at the hot end of the turbine wheel, spreading along journal bearing area
- “Heat soak” from the turbine side of the turbocharger through to the compressor side, causing discoloration to the turbine shaft and bearing housing
- Discolouration of internal components including thrust washer and flinger; occasionally without evidence of wear
- Collapse (loss of tension) to turbine end piston ring
- Carbon build up in the oil feeds and piston ring area
- Abnormal, excess wear to turbine end piston ring and groove
- Turbine blades appearance being uniformly curved downwards
- Small sections or edges of the turbine blades being fractured/partial loss of blades

Discolouration of shaft

- Check the DPF is in good working condition and is not clogged which can cause backpressure in the exhaust system which can negatively impact turbocharger performance.
- Ensure there are no leaks in the cooling lines
- Give the turbocharger time to cool, particularly after long journeys or harsh driving conditions

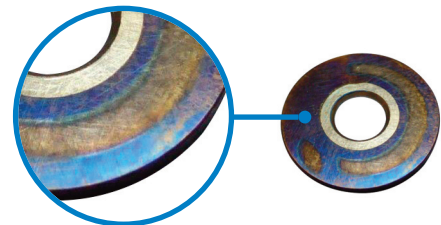
Discolouration of internal parts
