melett

PRECISION ENGINEERED
TURBOCHARGERS & PARTS

OVERHEATING

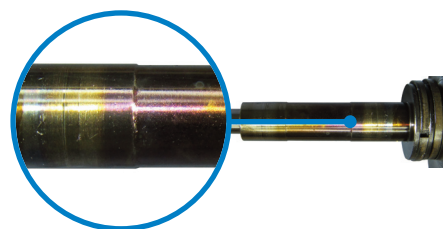
Discolouration of shaft

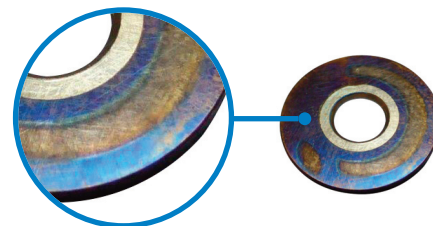
Discolouration of internal parts

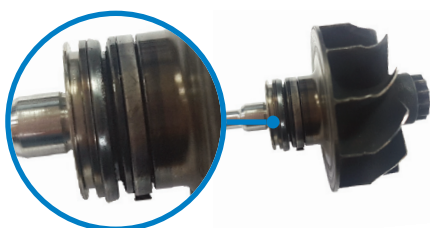
Excess wear to turbine end piston ring and groove
