melett

PRECISION ENGINEERED
TURBOCHARGERS & PARTS

LOOSE SHAFT NUT

What is loose shaft nut failure?

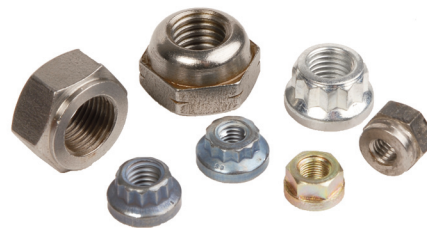
In turbocharger assemblies, the shaft nut plays a crucial role in securely holding the compressor wheel and other rotor group parts onto the shaft. The tightening of the shaft nut must follow precise procedures and settings to ensure proper functionality. Generally, shaft nuts have a left-hand thread, but in cases where the rotor parts have reverse rotation, a right-hand thread is used. They are sometimes referred to as 'locknuts' or 'impeller locknuts'.
